REPORT TO THE CITY OF VISALIA HISTORIC PRESERVATION ADVISORY COMMITTEE

SUBJECT: Historic Preservation Advisory Committee Item No. 2025-13: A request by Michael Murphy to conduct a reroof, add and replace fascia boards, restore or replace soffit boards, and replace wood rain gutters with metal rain gutters, on a single family residence within the D-MU (Downtown Mixed Use) Zone. The project site is located at 539 North Locust Street (APN: 094-354-005).

HPAC Item No. 2025-13 - Reroof, Fascia, Gutters

539 N LOCUST — FASCIA, GUTTER & COMPLETE ROOF REPLACEMENT

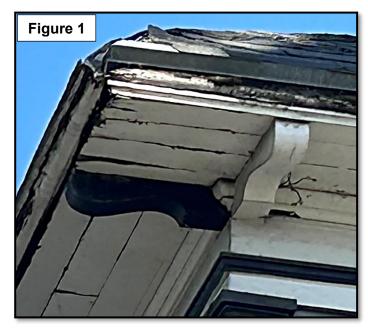
For the addition of fascia board to the exposed rafter tails, staff recommends that this not be approved. The portions of

the roofline with exposed rafter tails are considered distinctive and unique. At its July 2, 2025, site inspection, staff observed no obvious signs of damage to the exposed rafter tails. Without any specific damage noted, the obfuscation of this feature would only serve to remove one of the remaining original elements of the residence. Staff instead recommends application of Condition of Approval No. 2, requiring that the exposed rafter tails be preserved and maintained.

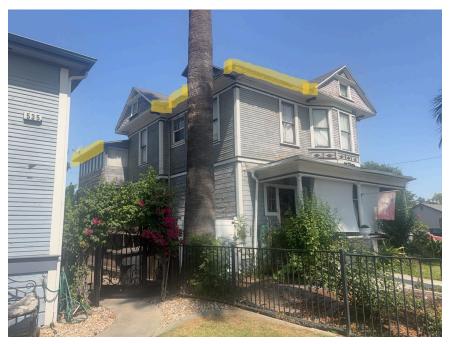
We will be adding fascia to the eaves of the second story, fascia size to match existing.

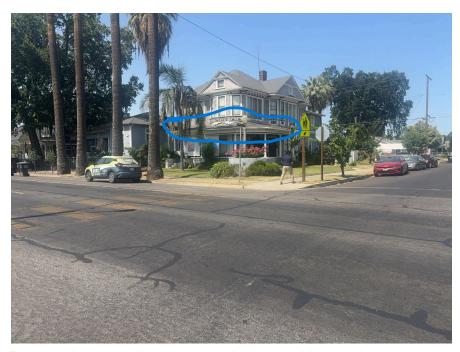
Remove these existing gutters and replace with new 5k style wrap around gutters

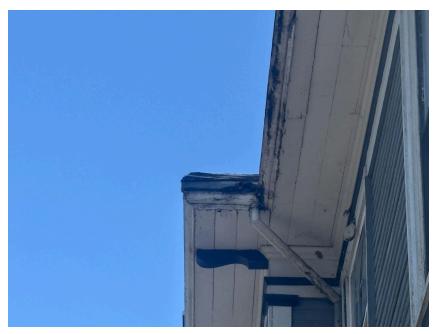
Evidence of wood rot in the original wooden gutter system, which has carried into fascia area

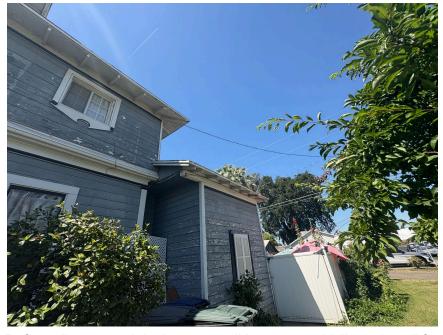
Rafter tails exposed, in decent condition, we would like to install fascia on all exposed rafter tails

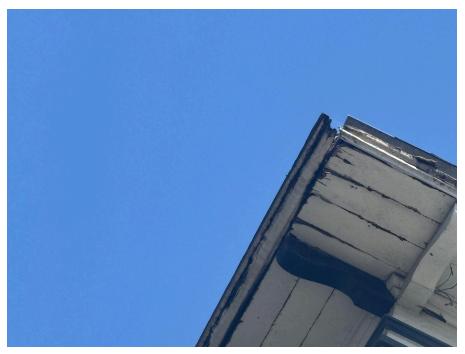
More signs of wood rot from exposed wooden gutter with water deterioration inlet from eave. (recommending new fascia and gutters installed)

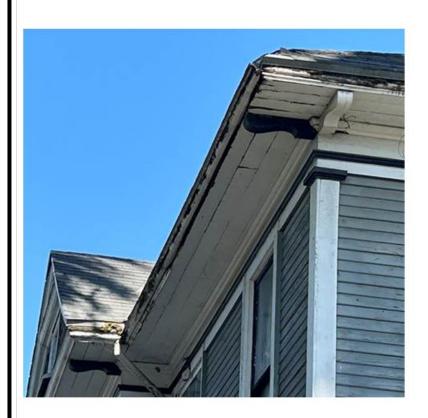
They shall be preserved, if upon deeper discovery that rot is present we can replace but as for now we are planning to keep as much of original material as possible

Michael, can you please let me know if there's any plan to address the decorative rafter tails depicted below? Will these be preserved or removed? Please let me know, thanks!
